**HATO MONTEREY CORPORATION  
13601 SW 207TH AVENUE PARCEL  
MIAMI-DADE COUNTY, FLORIDA**

**FOLIO NO. 30-5815-000-0800**

**ENVIRONMENTAL ASSESSMENT REPORT  
OCTOBER 2016**

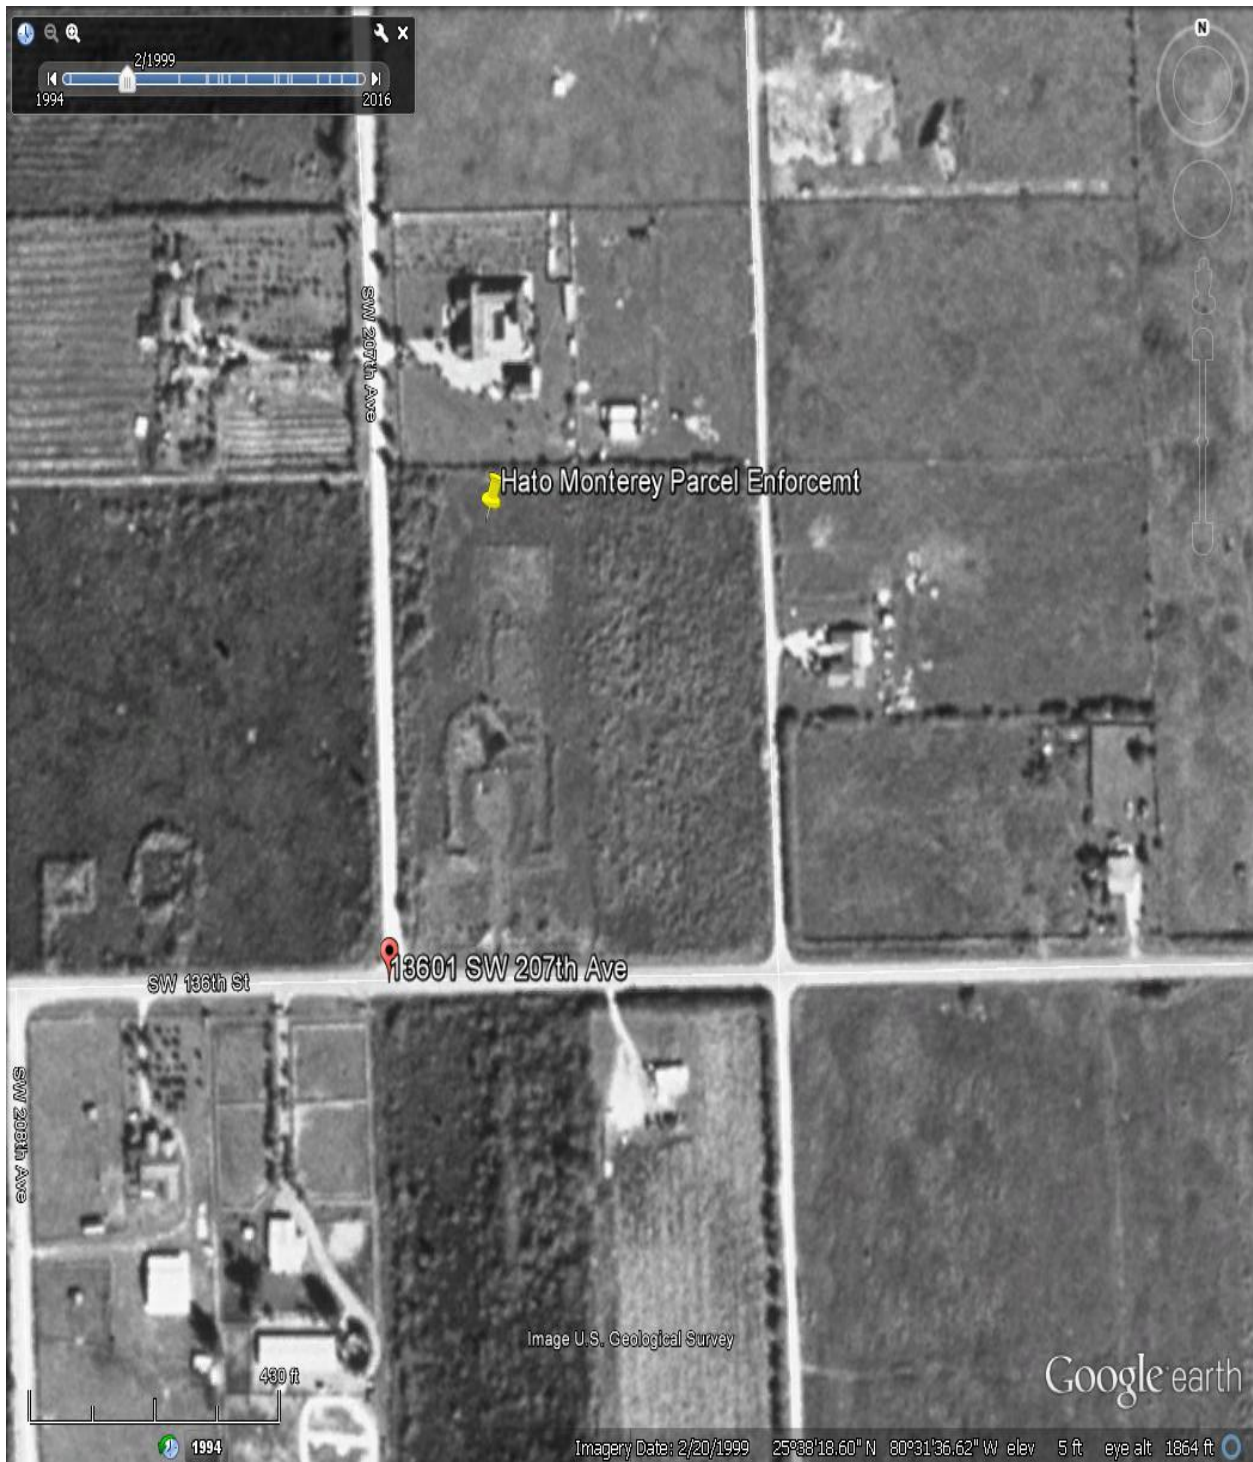
**FIGURE 2A: 1999 AERIAL PHOTOGRAPH OF HATO MONTEREY PROPERTY  
FILL ACTIVITY CAN BE OBSERVED ON THE 13691 SW 207<sup>TH</sup> AVENUE PROPERTY**

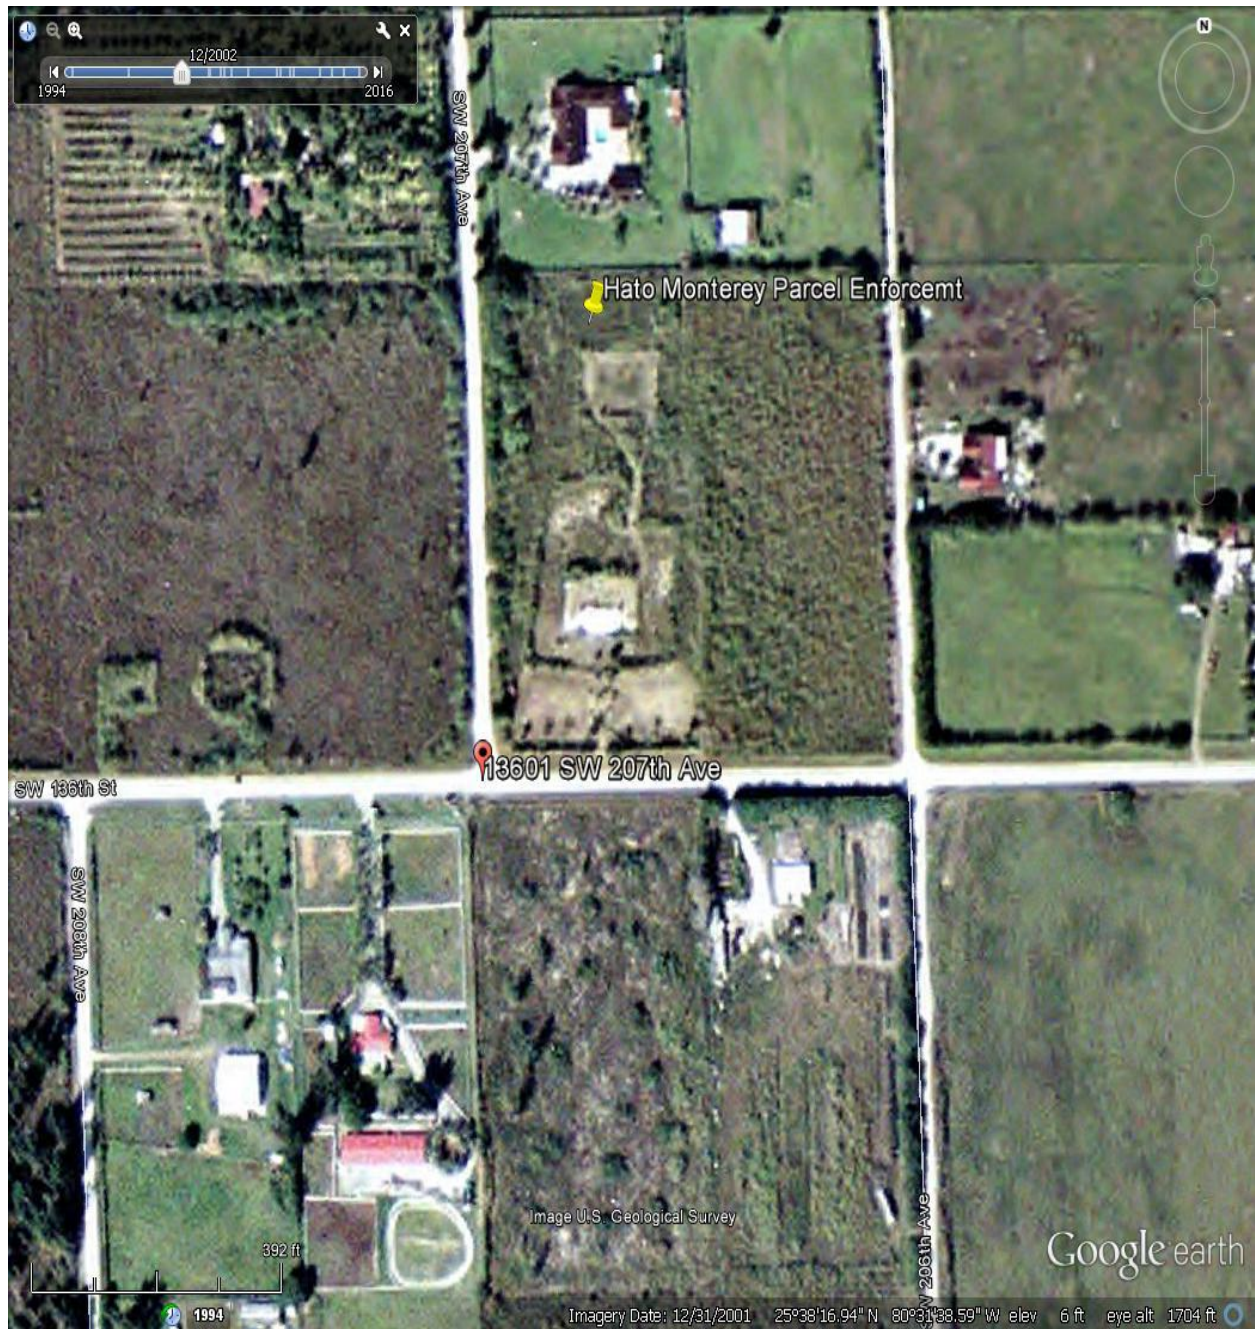
**FIGURE 2A: 2002 AERIAL OF HATO MONTEREY PROPERTY**  
**FILL HAS BEEN ADDED TO THE SOUTH HALF OF THE PROPERTY AND**  
**A STRUCTURE IS EVIDENT**

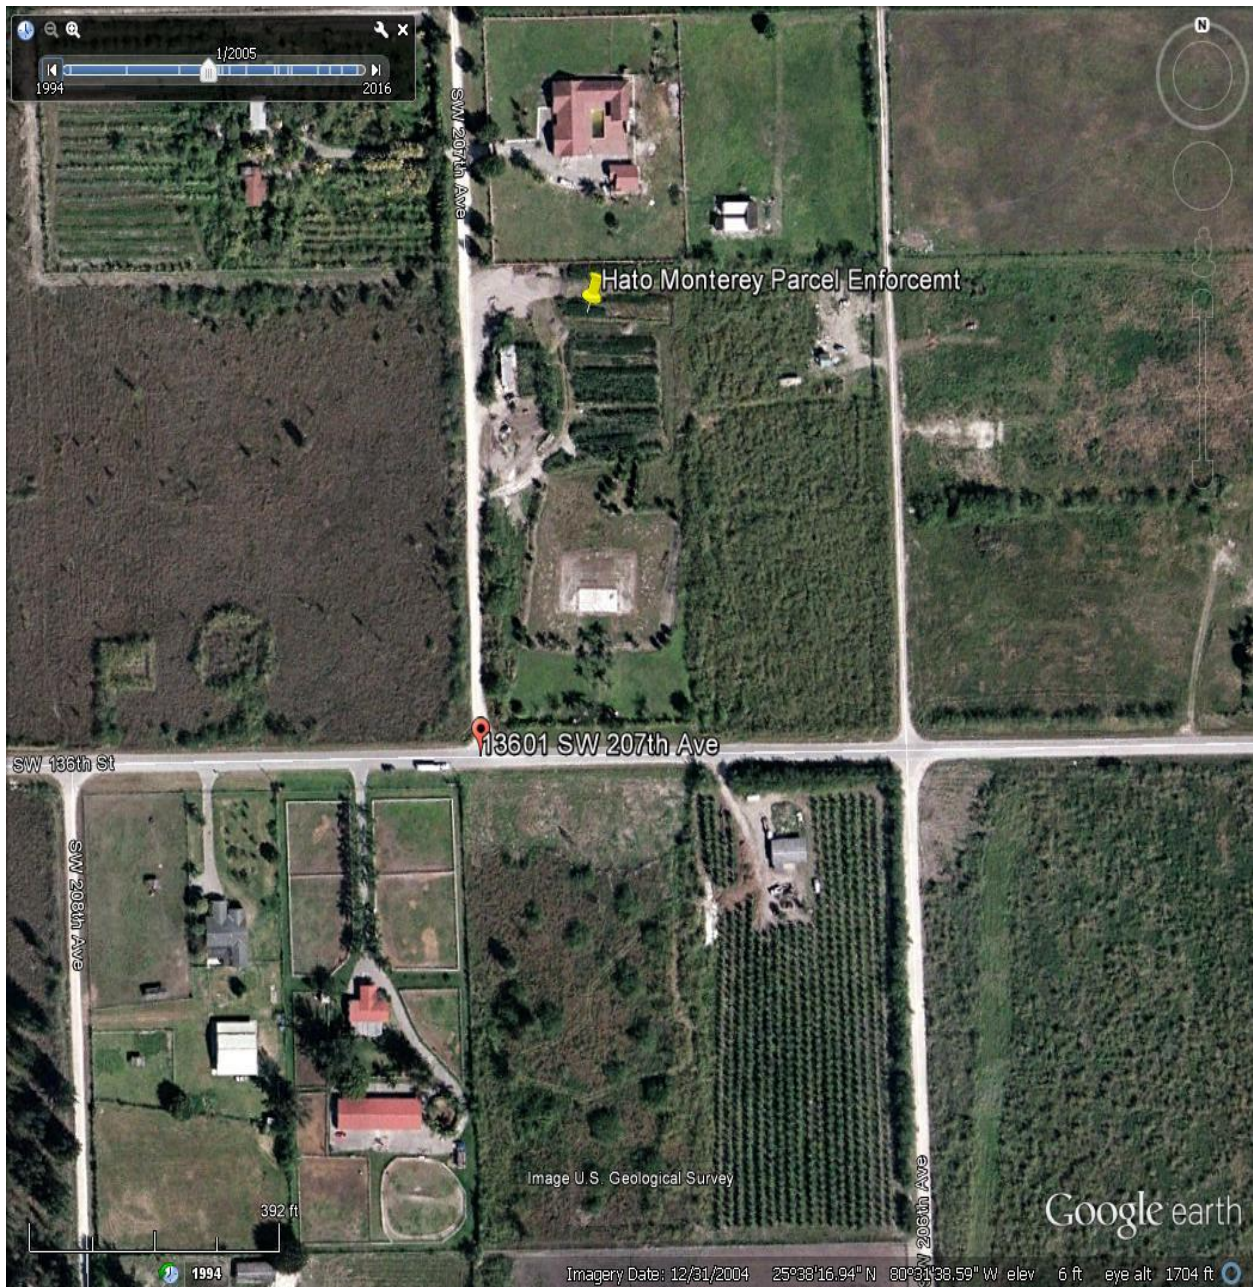
FIGURE 2A: 2005 AERIAL PHOTOGRAPH OF HATO MONTEREY PROPERTY  
THE STRUCTURE SEEN IN THE 2002 AERIAL PHOTOGRAPH HAS BECOME A PLANT  
NURSERY WITH FILL ADDED TO THE NORTHWEST CORNER OF PROPERTY.

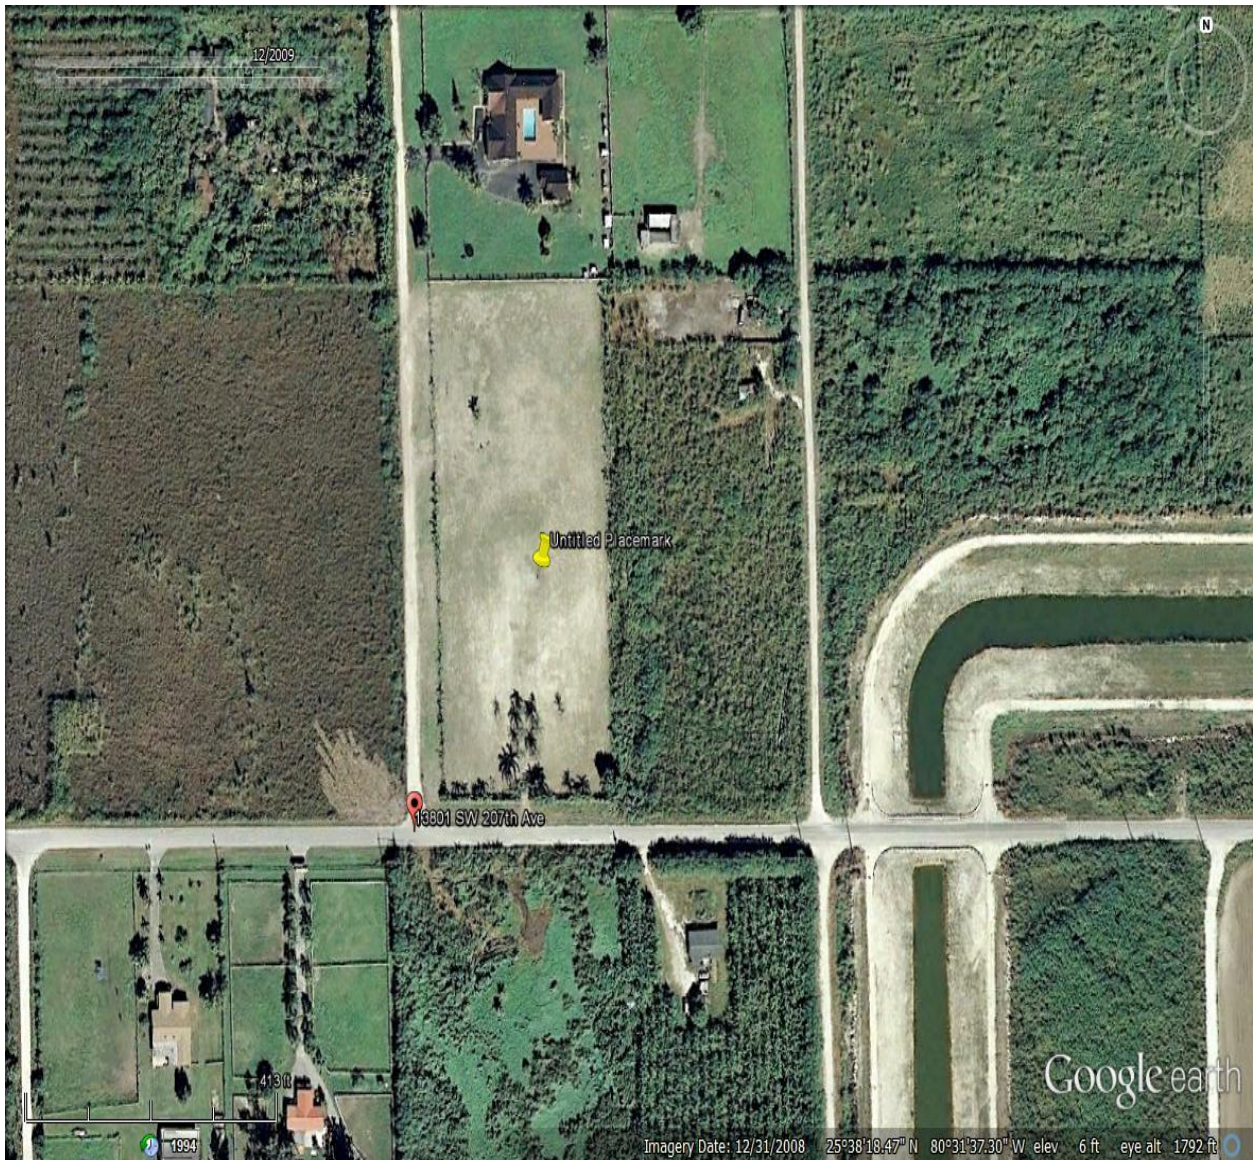
**FIGURE 2A: 2008 AERIAL PHOTOGRAPH OF HATO MONTEREY PROPERTY**

In 2005, 2006, and 2007 aerials, the nursery plant operation continued to exist on the property (**Attachment 1: 2005 – 2007 aerial photographs of 13601 SW 207<sup>th</sup> Ave, Miami, FL**). In 2008, the property appears to have been cleared of structures including the nursery plant facilities, and possibly rock-plowed (**Attachment 1. 2008 Aerial Photograph of 13601 SW 207<sup>th</sup> Ave Miami, FL**). This is most likely the period when the loose, rocky top soil was removed from the property.

**THE PROPERTY HAS BEEN CLEARED & SCRAPED DOWN TO LIMESTONE**

**BEDROOD IN THE SOUTHERN HALF OF THE PROPERTY.**

**NO SITE OF INUNDATION OR WETLANDS.**

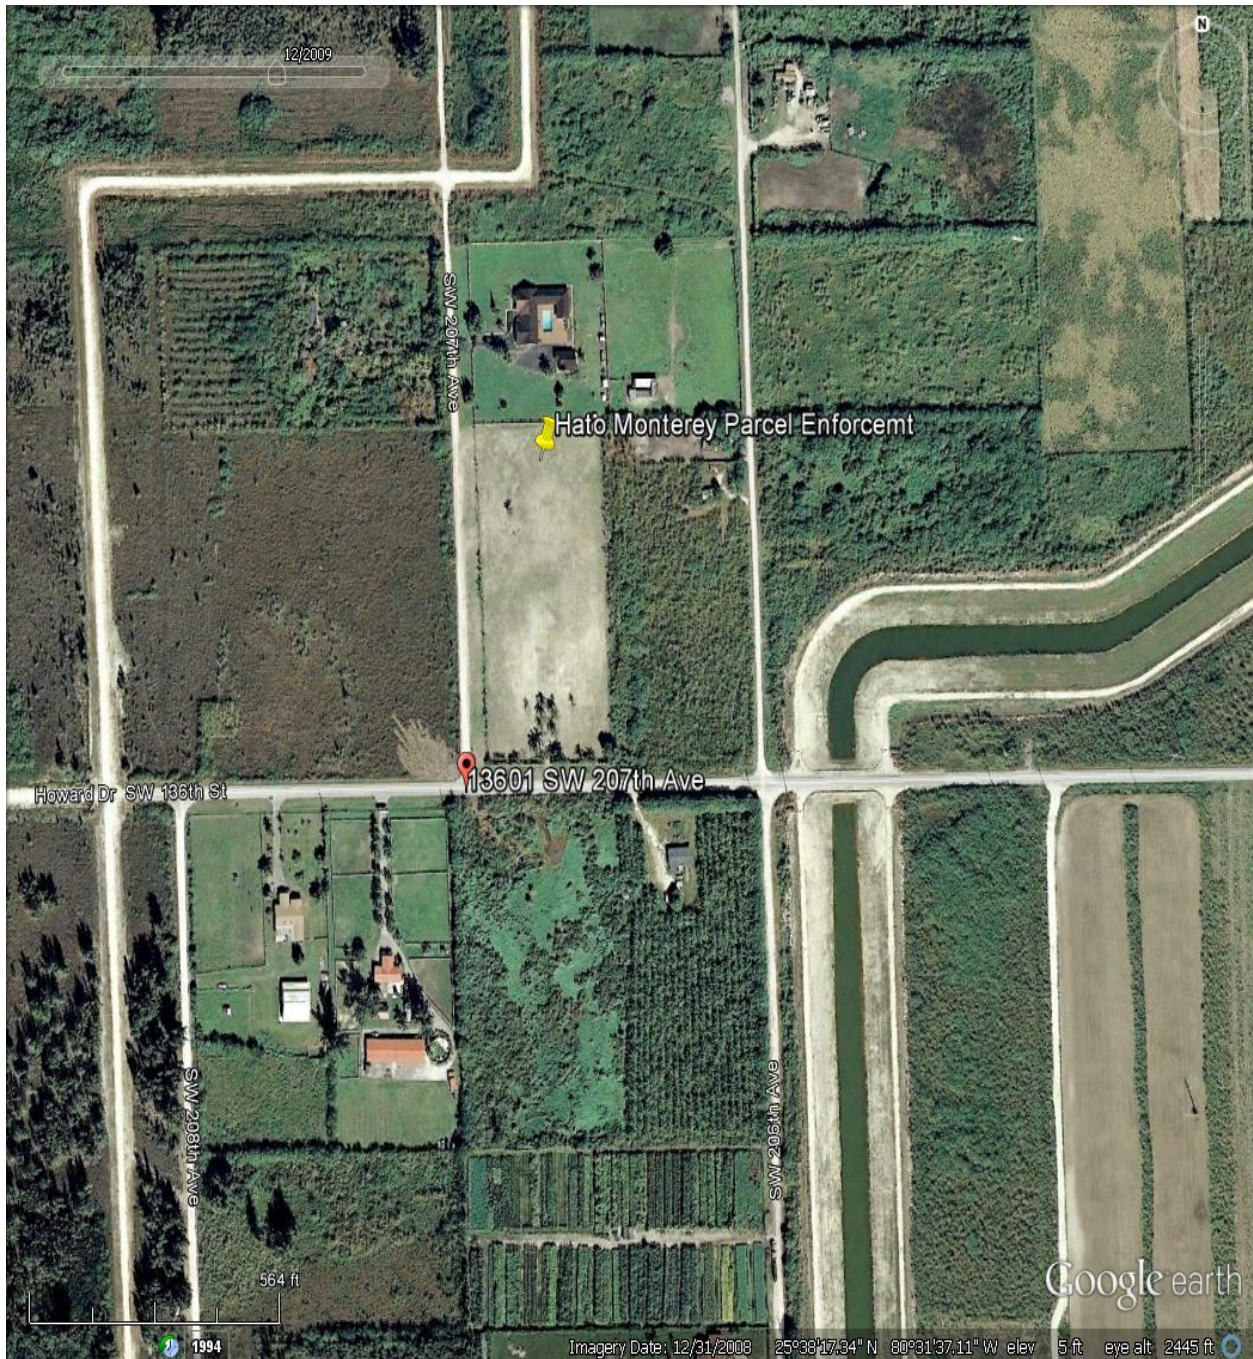
**FIGURE 2A: 2009 AERIAL PHOTOGRAPH OF HATO MONTEREY PROPERTY**  
**THE PROPERTY HAS BEEN ROCK-PLOWED. PLEASE NOTE THE SOUTH ENTRANCE**  
**WITH THE LANDSCAPING, ENTRANCE WITH WHITE SIGNATURE INDICATIVE OF**  
**HIGHER ELEVATION OF PRESENCE FILL MATERIAL**

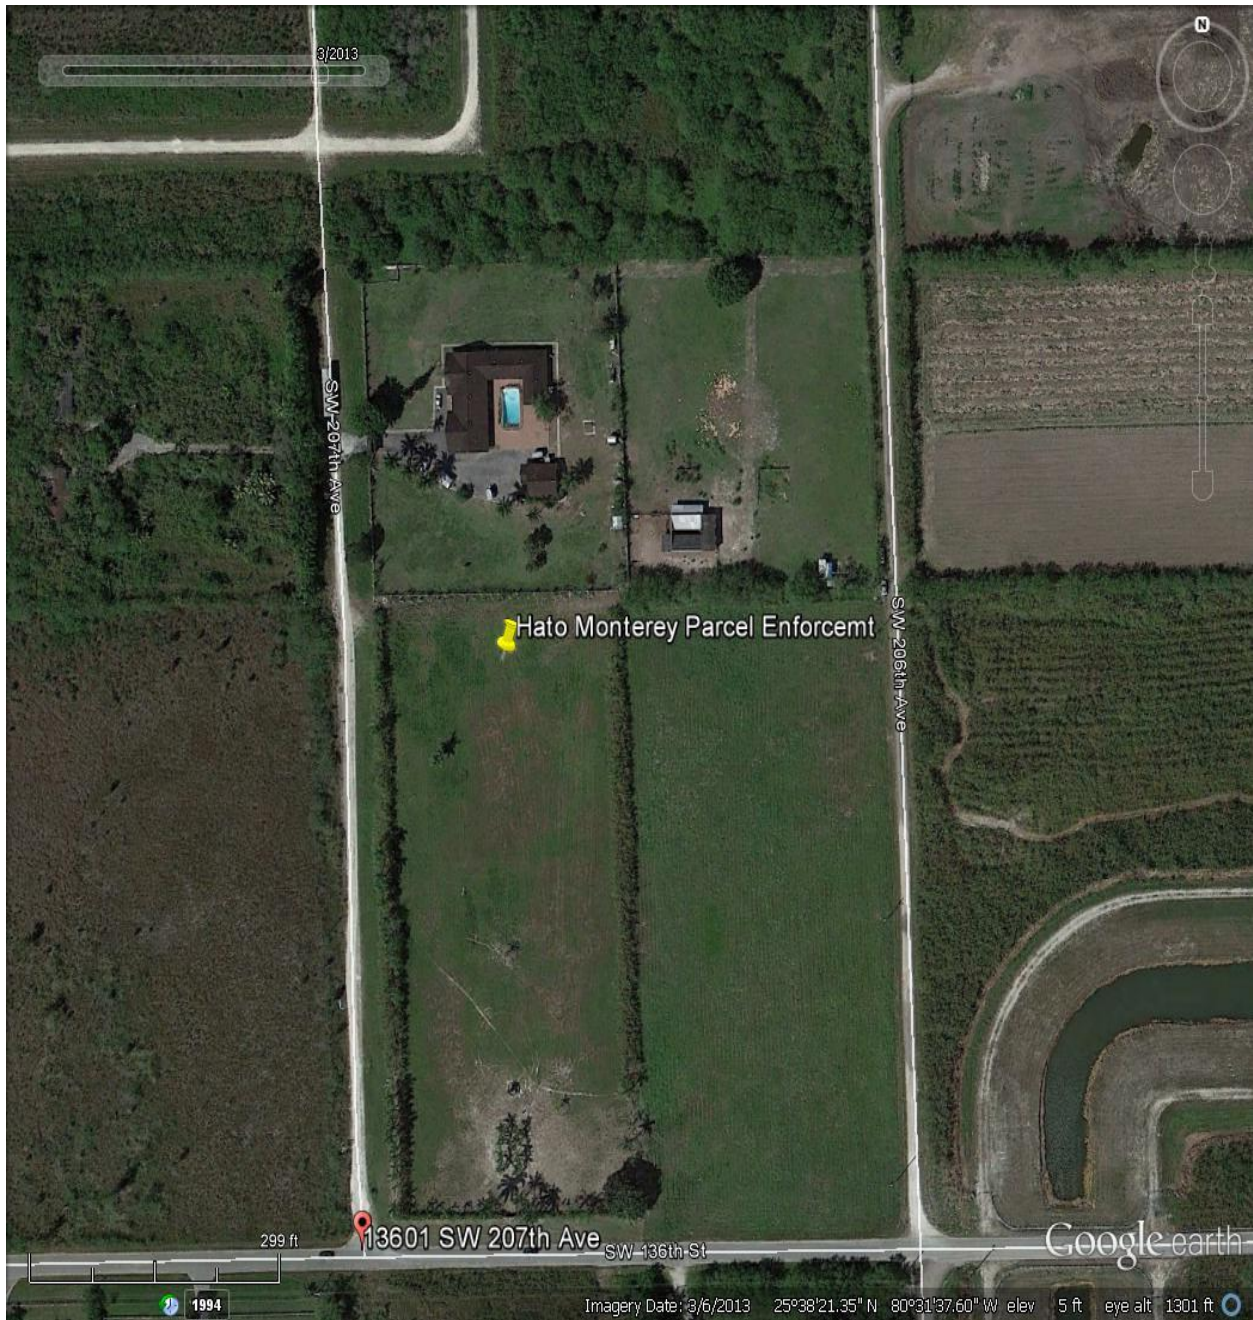
**FIGURE 2A: 2013 AERIAL PHOTOGRAPH OF HATO MONTEREY PROPERTY**

**THE HATO MONTEREY PROPERTY REMAINS THE SAME AS PRIOR YEARS.**

**PLEASE NOTE THE SOUTH ENTRANCE WITH WHITE-GRAY SIGNATURE INDICATING HIGHER ELEVATION OR BEDROCK AND BROWN SIGNATURE DENOTING AREAS OF ROCK.**

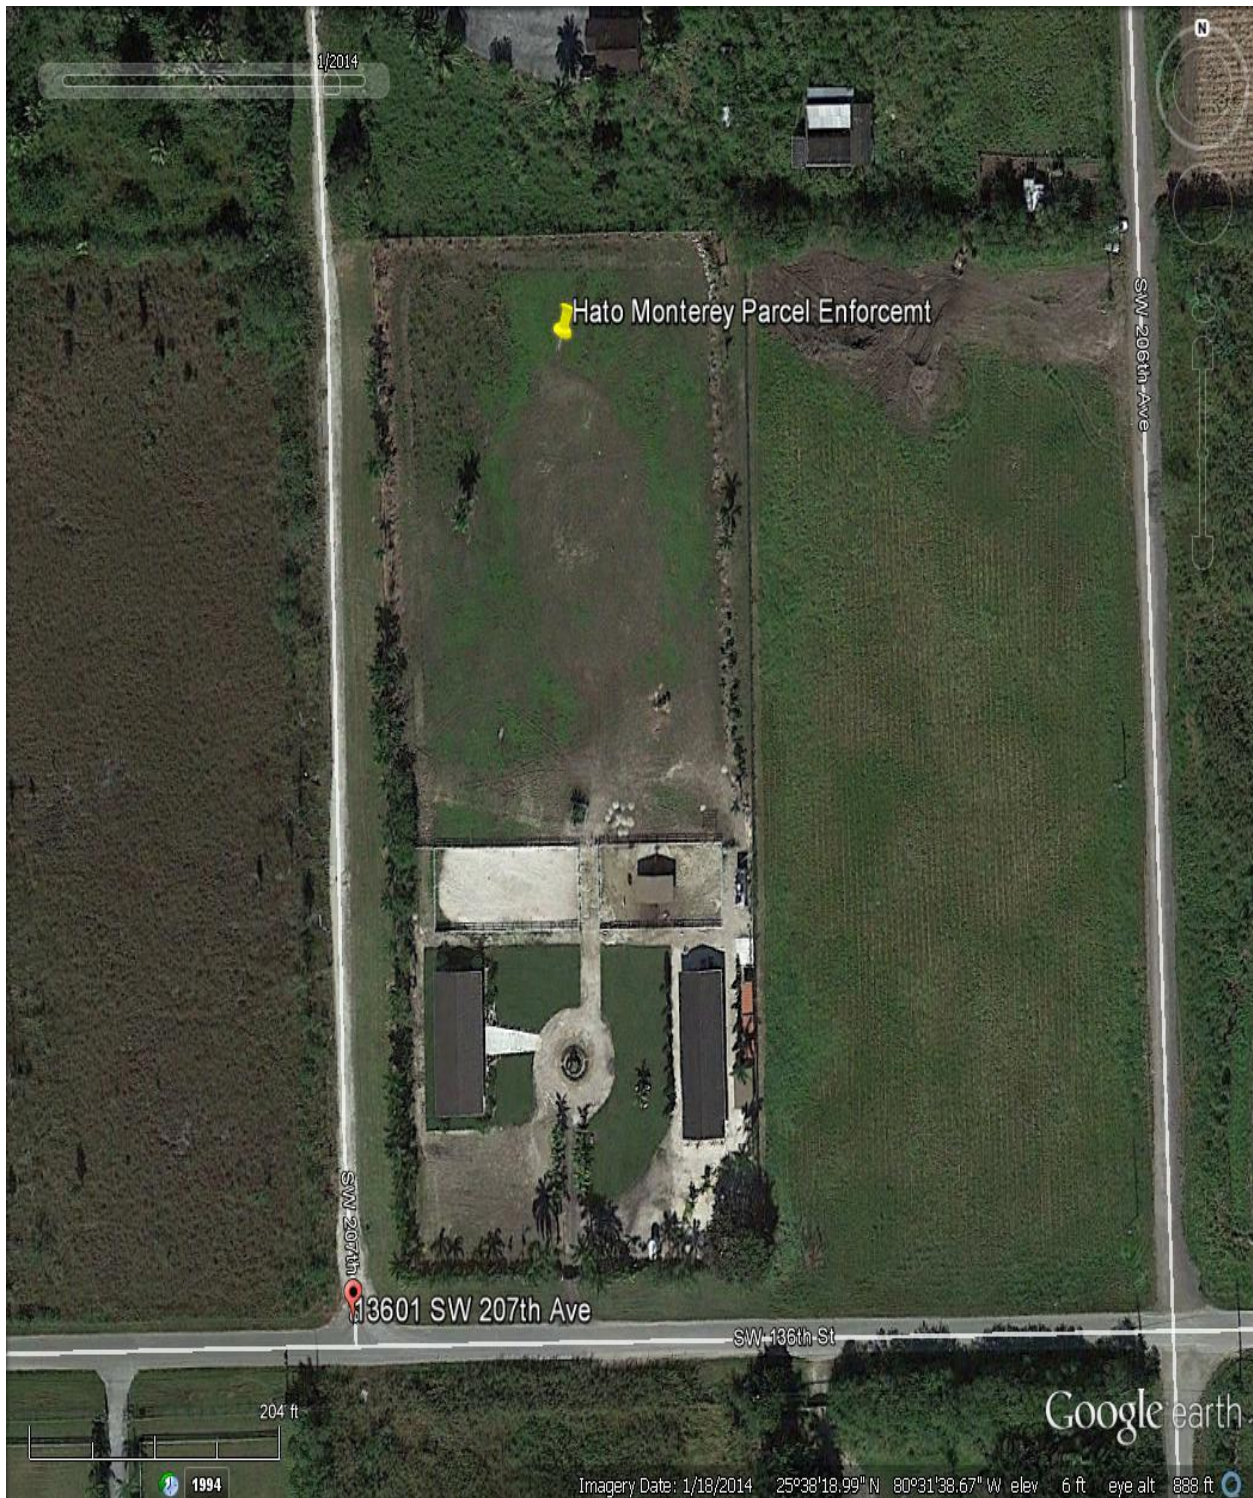
**FIGURE 2A: 2014 OF CONSTRUCTED EQUESTRIAN FACILITIES ON HATO MONTEREY PROPERTY. FILL MATERIAL SIGNATURE IS WHITE AS OBSERVED UNDER STABLE ON SE SIDE OF SITE AND PADDOCKS NORTH OF THE STABLE AND DINING AREA ON SW SIDE OF PARCEL; GRAY IS LIMESTONE BEDROCK.**

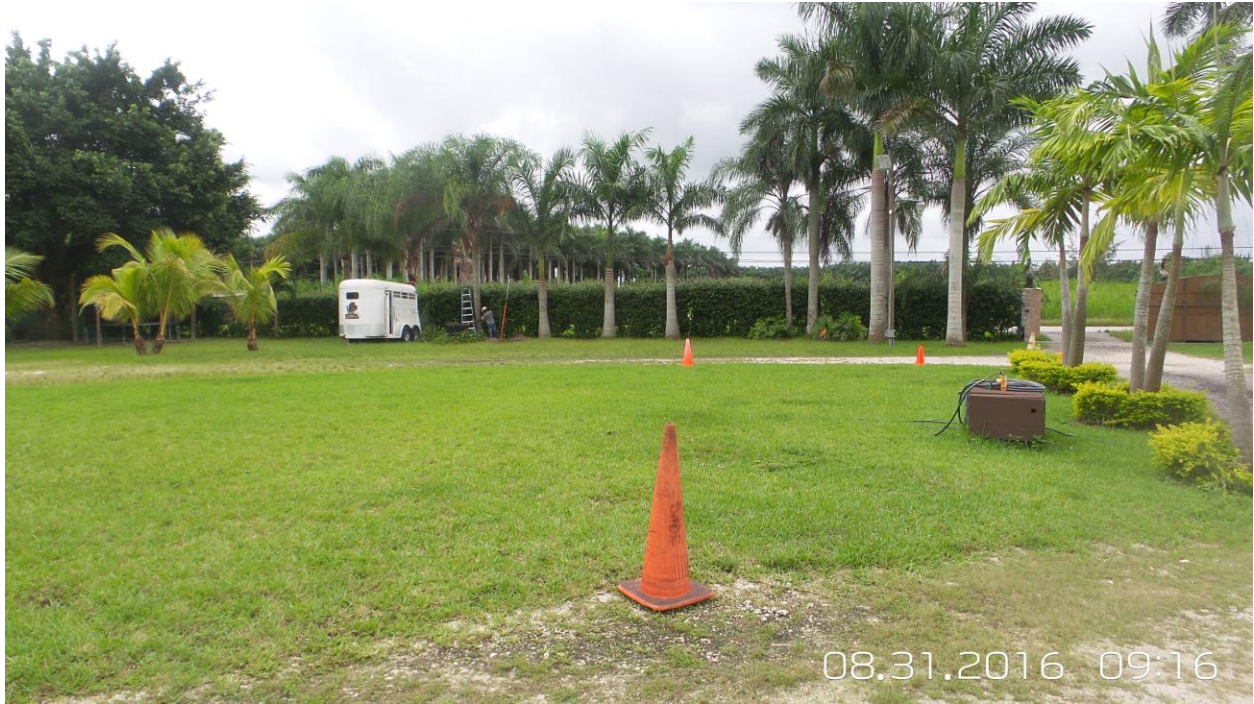
Photo #3 Hato Monterey SE View From Circle Driveway  
Bedrock is visible in Foreground

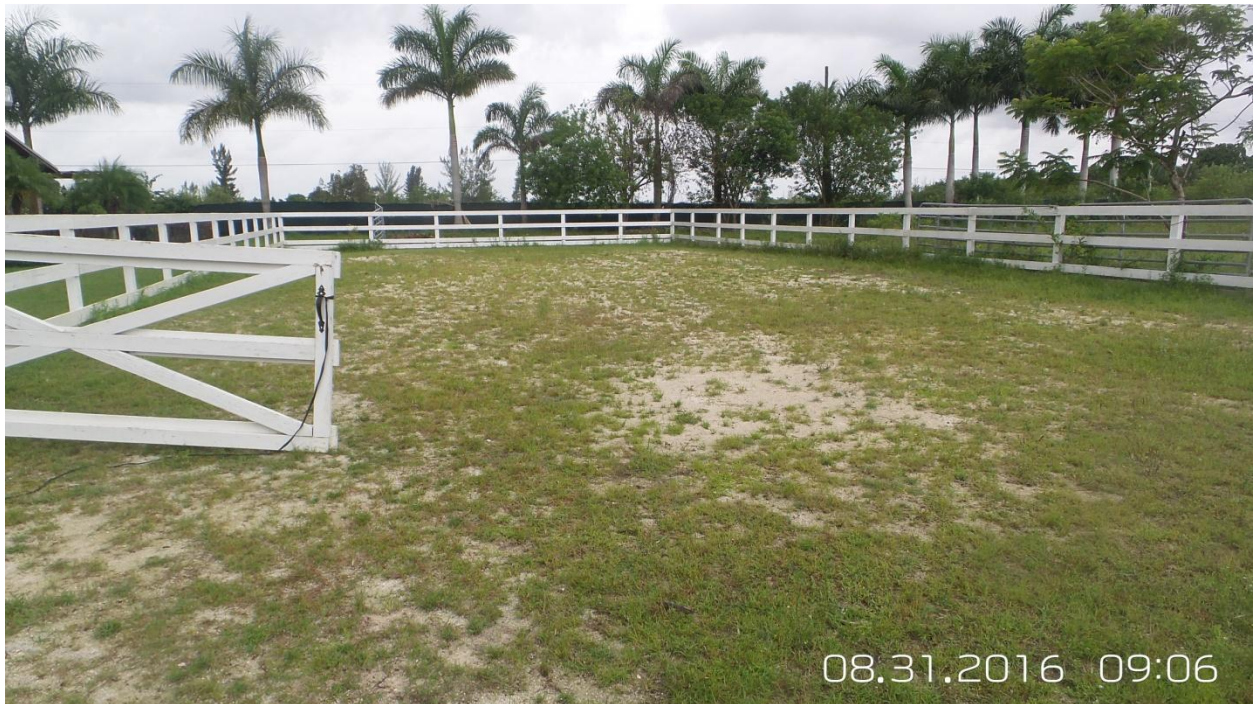
Photo #6 Hato Monterey West Paddock West View from East End of Paddock Elevations 6.25 ' to 6.58"

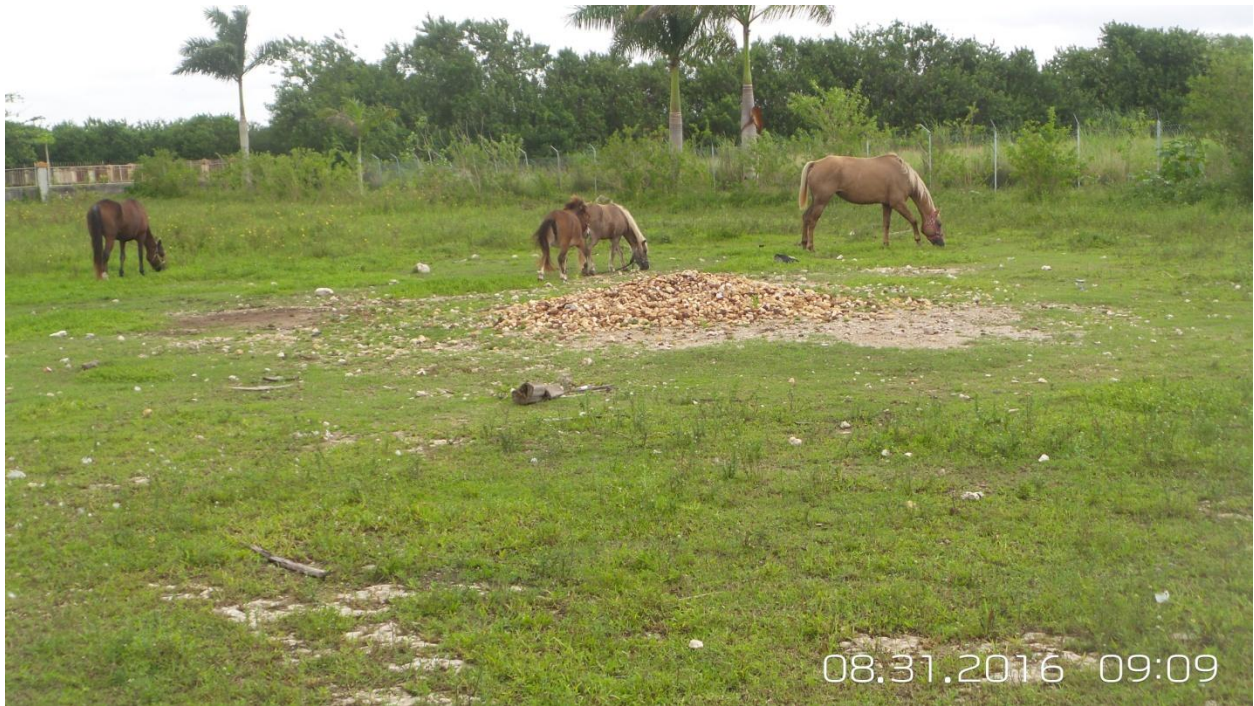
Photo #7 Hato Monterey View of Natural Area North of Paddocks. Limestone Bedrock can be seen In foreground with rock pile. Elevations between 6.5' and 6.78.

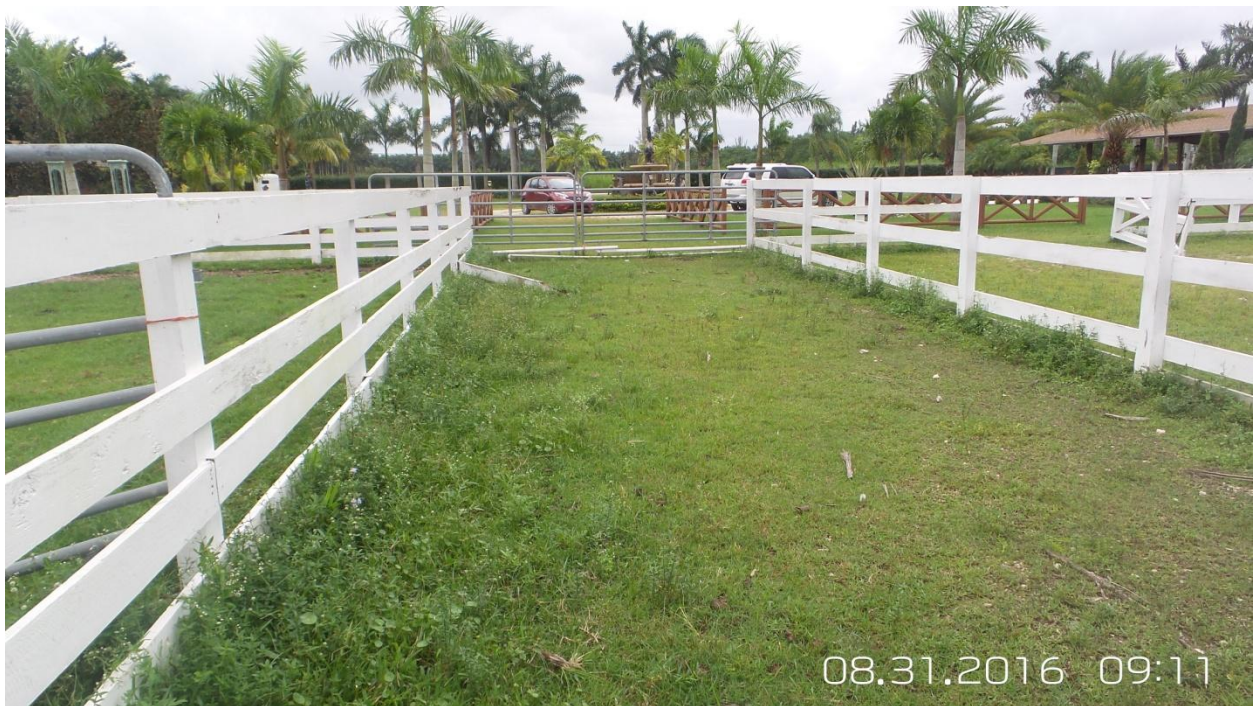
Photo # 8 Hato Monterey Area between Paddocks. Bedrock visible Elevation +/- 6.5'

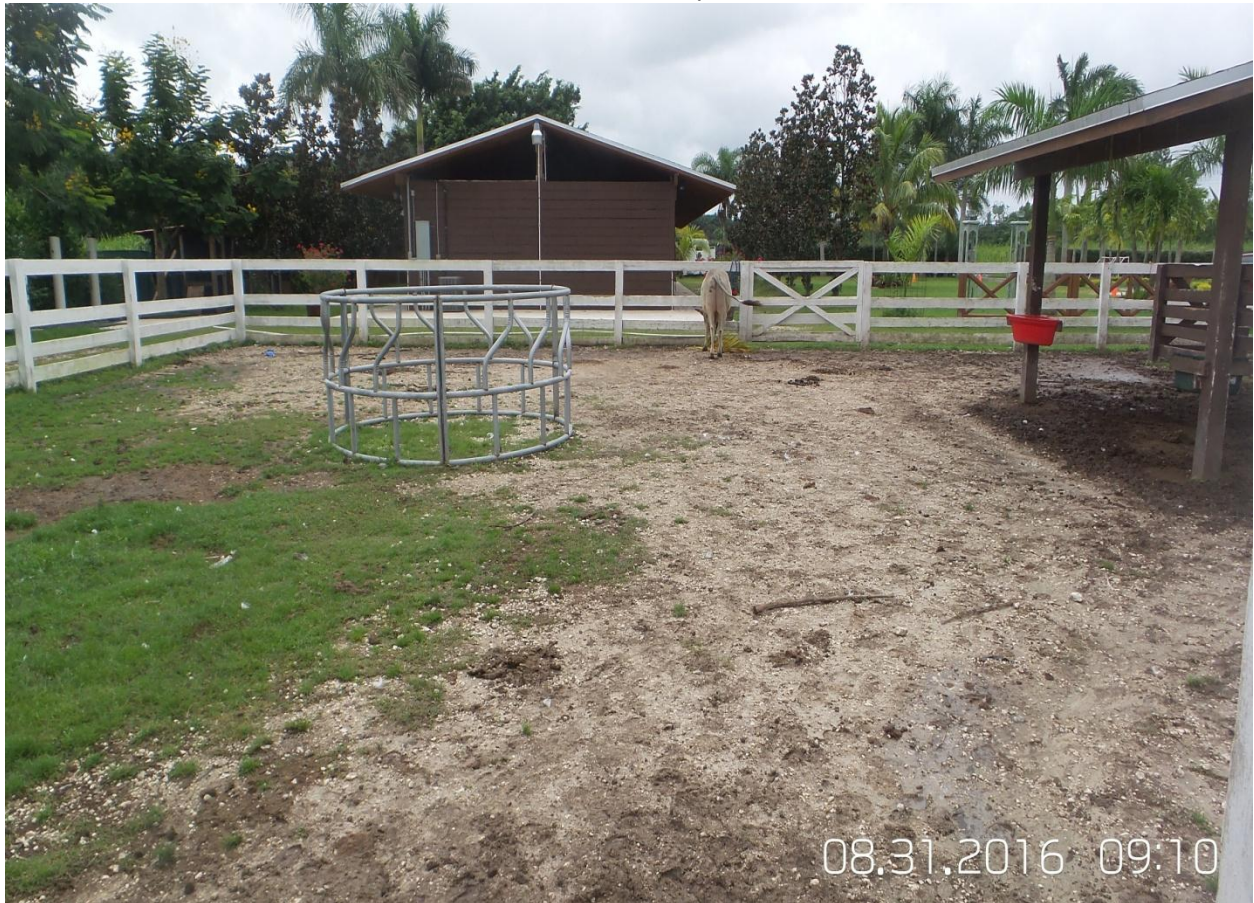
Photo #9 Hato Monterey East Paddock South View Looking at Stable.

Limestone Bedrock Visible. Elevations 6.8' to 7.5'
